Manhole Inspection Summary

Manhole # S37WW_023MH

Location Address: **419 31ST ST**

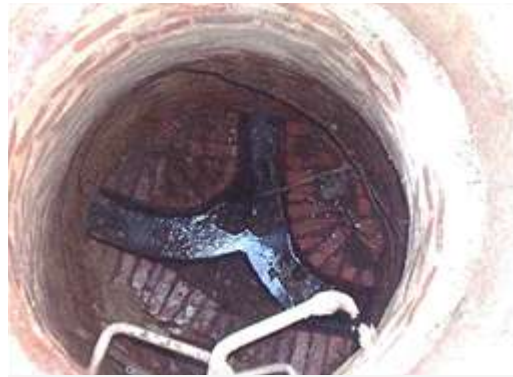
Top View

Bench and Channel debris.

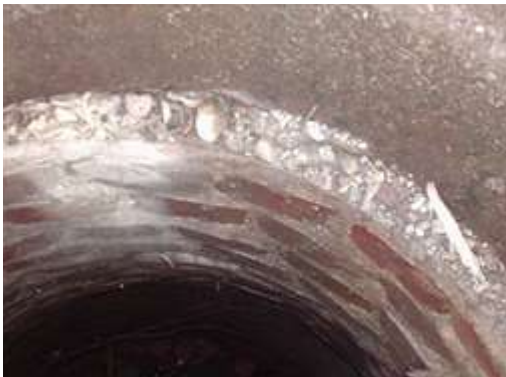
Defect

Frame Offset: **3** (in.) Condition: ☐ Sound ☐ Cracked ☒ **Leaks**

Condition: ☐ Sound ☐ Cracked ☐ Root Intrusion ☐ Loose Brick ☒ **Deteriorated**

Infiltration: ☐ None ☒ **Joint** ☐ Cracks ☐ Mortar ☐ Roots ☒ **Wall**

Frame leaks. Frame offset. Adjustment deterioration and infiltration.

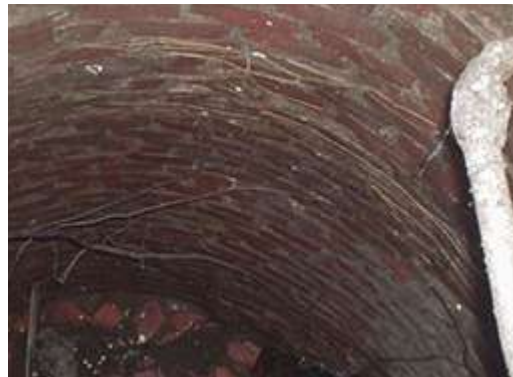
Defect

Condition: ☐ Sound ☐ Cracked ☒ **Root Intrusion** ☐ Loose Brick ☐ Deteriorated

Infiltration: ☐ None ☐ Joint ☐ Cracks ☐ Mortar ☒ **Roots** ☒ **Wall**

Barrel root intrusion and infiltration.

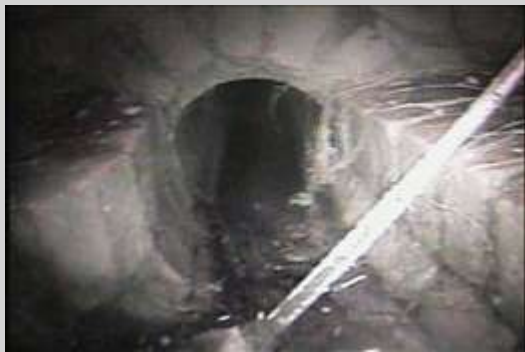
8 in. Circular Gravity Sewer Pipe Out @ 12 O'Clock

Deposits: ☐ None ☒ **Mud** ☐ Sludge ☐ **Debris** ☐ Grease

Infiltration: **Evidence** Pipe Seal Cond: **Roots**

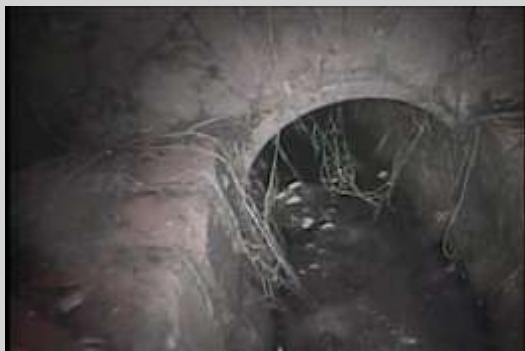
8 in. Circular Gravity Sewer Pipe In @ 3 O'Clock

Deposits: ☐ None ☒ **Mud** ☐ Sludge ☒ **Debris** ☐ Grease

Infiltration: **None** Pipe Seal Cond: **Roots**

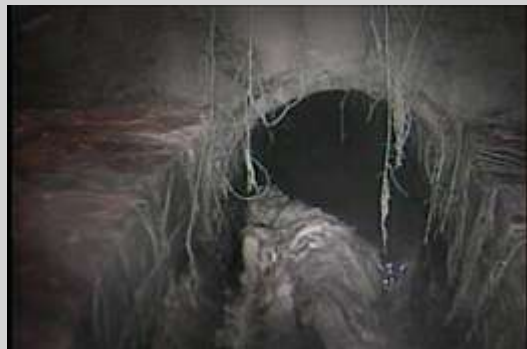
Pipe In @ 10 O'Clock

Deposits: ☐ None ☐ Mud ☐ Sludge ☒ **Debris** ☐ Grease

Pipe Seal Cond: **Roots**
